National Highway
Traffic Safety
Administration

Case Vehicle (A): 1998 Ford
Type: F-150, 4x2 3-door pickup
Driver: 20-year-old male
CDC: 01-RYEW-3, 99-0000-0

Vehicle (B): 1994 Ford
Type: Taurus, 4-door sedan
Driver: 30-year-old female
CDC: 11-FDEW-2, 09-LPEW-2

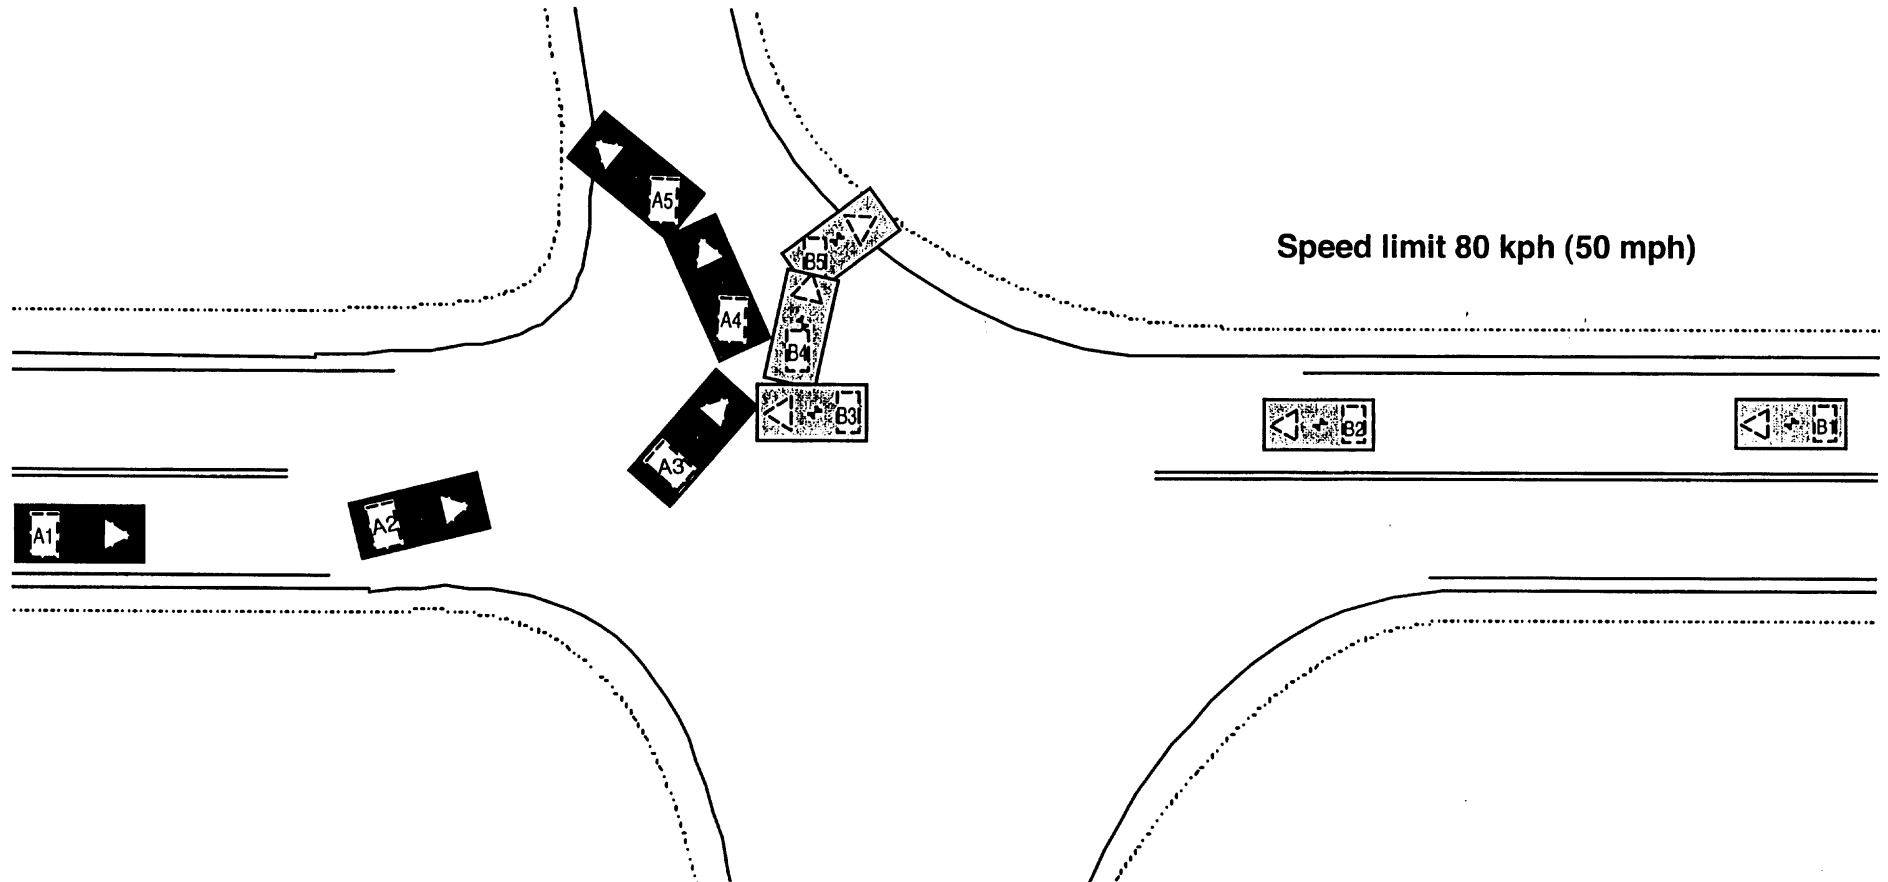
ACCIDENT SCHEMATIC

ACCIDENT DESCRIPTION: Case vehicle (A) was traveling north on a dry 2-lane roadway approaching a 4-leg intersection. Vehicle (B) was traveling in the southbound lane of the same roadway. As case vehicle (A) entered the intersection, the driver of case vehicle (A) made a left turn across the path of vehicle (B). The driver of vehicle (B) was unable to stop in time to avoid a collision, and the front of vehicle (B) struck the right-front corner of case vehicle (A). The impact caused case vehicle (A) to rotate counterclockwise and side-slap vehicle (B) before it came to rest facing southwest. After the side-slap, vehicle (B) rotated clockwise and came to rest facing northwest.

(Slide 1) Case vehicle (A) was traveling north in the northbound lane of a straight section of a dry asphalt, two-lane roadway, with a speed limit of 80 kph (50 mph), and was approaching a four-leg intersection. Vehicle (B) was traveling south in the southbound lane of the same roadway. (Slides 2, 3) As case vehicle (A) entered an intersection with a two-lane road, the driver of case vehicle (A) began to make a left turn across the path of vehicle (B) to travel west. The driver of vehicle (B) was unable to stop in time, and the front of vehicle (B) struck the right-front corner of case vehicle (A). The impact caused case vehicle (A) to rotate counterclockwise and side-slap vehicle (B) before it came to rest facing southwest. After the side-slap, vehicle (B) rotated clockwise and came to rest facing northwest.

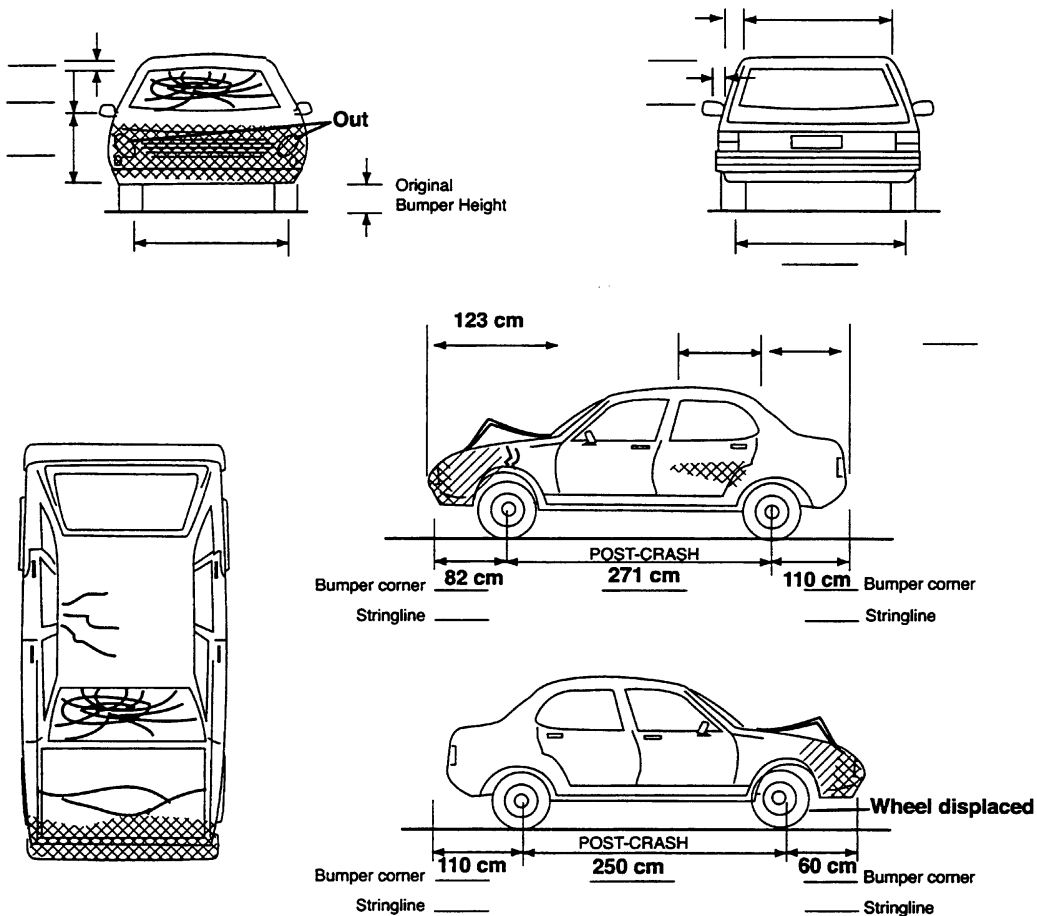
VEHICLE DAMAGE

150 cm

98 %

(Slide 5) Damage to vehicle (B) was severe. The direct-damage length was 150 cm. It began at the right-front bumper corner and involved the entire frontal plane. The maximum crush was 38 cm and occurred 78 cm inboard of the right-front bumper corner. The right wheelbase was reduced 19 cm, and the left wheelbase was extended by 2 cm. The direct damage from the side-slap impact began just forward of the left-rear axle, and the maximum crush occurred just forward of the left C-pillar.

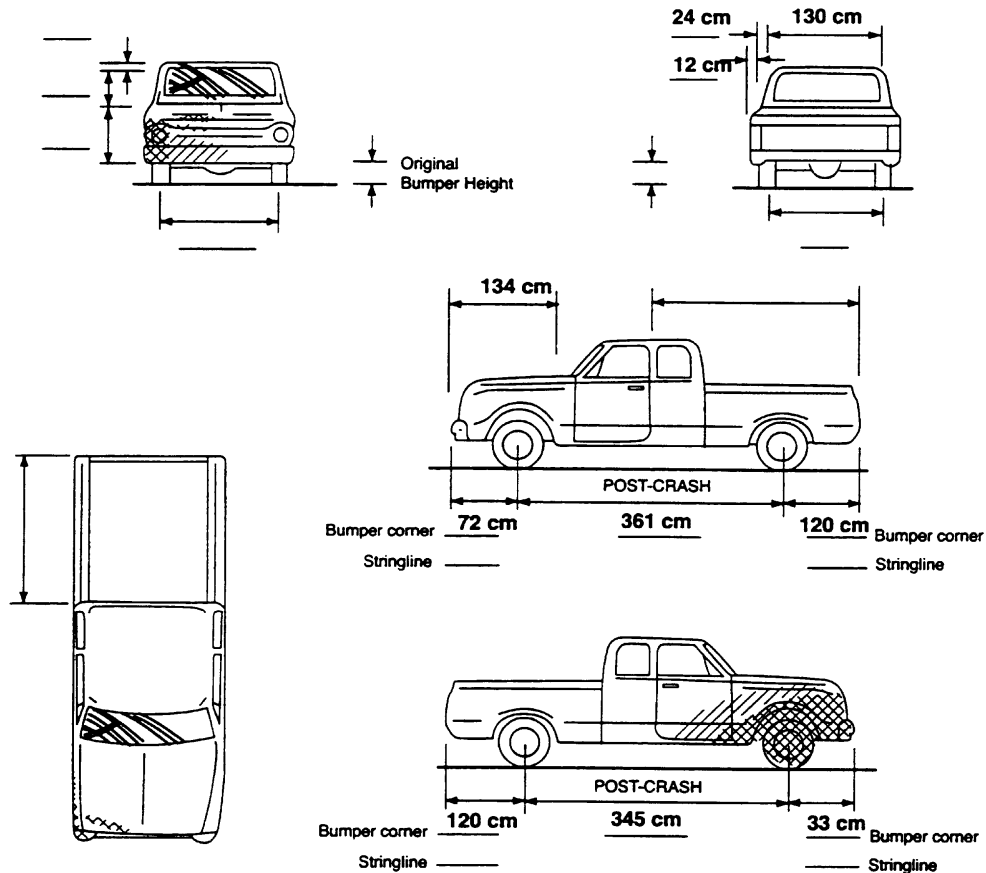
MEASUREMENTS IN CENTIMETERS

* Plus 10-cm for bumper. GTI specs appear to indicate RO only to end of box

(Slide 4) Damage to case vehicle (A) was moderate. The direct-damage length was 200 cm. It began at the right-front corner and extended rearward along the right fender to approximately the mid-point of the right-front door. The maximum crush was 50 cm and occurred at the right-front fender corner. The right wheelbase was reduced 8 cm, and the left wheelbase was extended by 8 cm. The side-slap impact produced no residual crush to the right-rear bumper corner.

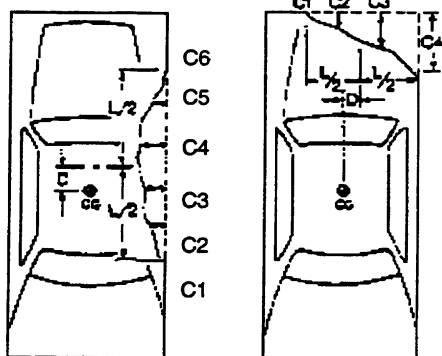
CRUSH PROFILE IN CENTIMETERS

DL 150
UDL 0

Specific Impact Number	Plane of Impact C-Measur.	Direct Damage		Field L	C ₁	C ₂	C ₃	C ₄	C ₅	C ₆	±D
		Length (DDL)	Max Crush								
1	Bumper	150	C4	130	19	23	30	39	43	52	0
					-16	-6	-1	-1	-6	-16	
					3	17	29	38	37	36	
1	1	150	038	130	003	017	029	038	037	036	+000
13	14	15 16 17	18 19 20	21 22 23	24 25 26	27 28 29	30 31 32	33 34 35	36 37 38	39 40 41	42 43 44 45
2

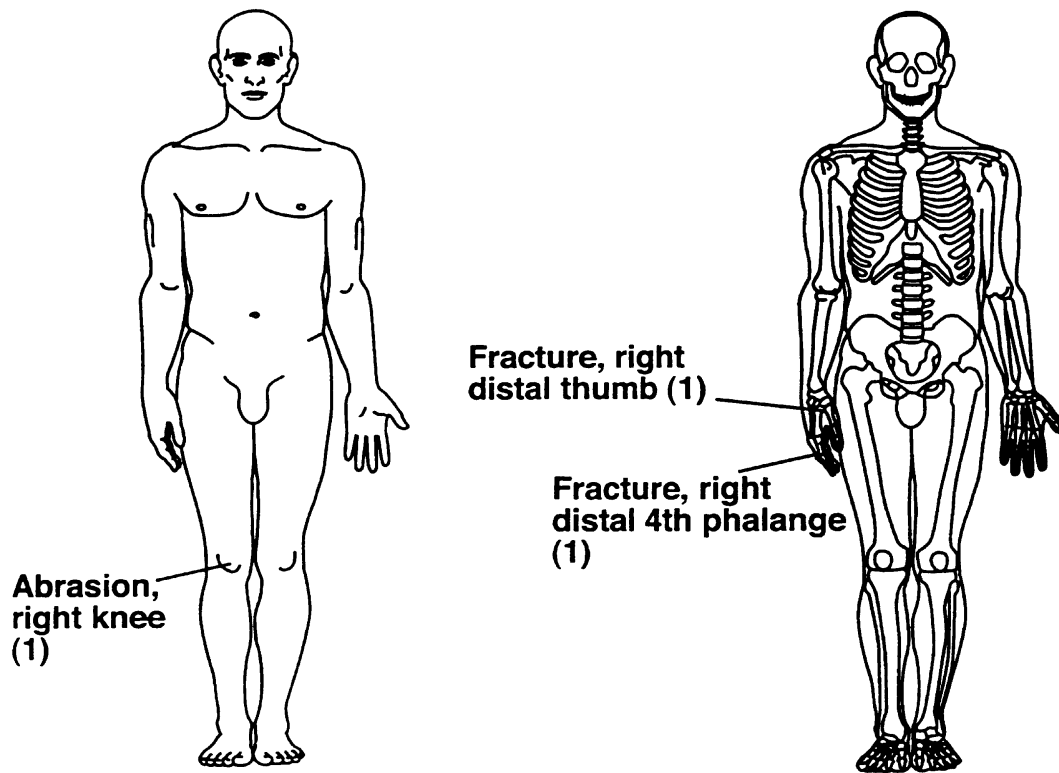
INDICATE LOCATION OF INJURIES.

Injury Description	A.I.S.	Injury Source		
		Definite	Probable	Possible
Fracture, distal right thumb	1		Steering-wheel rim	Rearview mirror/airbag fling
Fracture, distal right 4 th phalange	1		Rearview mirror	
Abrasion, right knee	1		Knee bolster	
<u>Maximum A.I.S. Level</u>	<u>1</u>			
<u>Injury Severity Score</u>	<u>2</u>

The following table and (slide 38) attached drawing summarize the injuries sustained by the driver.
